PROCEEDINGS  
OF THE  
SMRM DEGRADATION STUDY WORKSHOP

Organized by:  
The Satellite Servicing Project  
Goddard Space Flight Center

May 9-10, 1985

**SUMMARY OF THE SMRM DEGRADATION  
STUDY WORKSHOP**

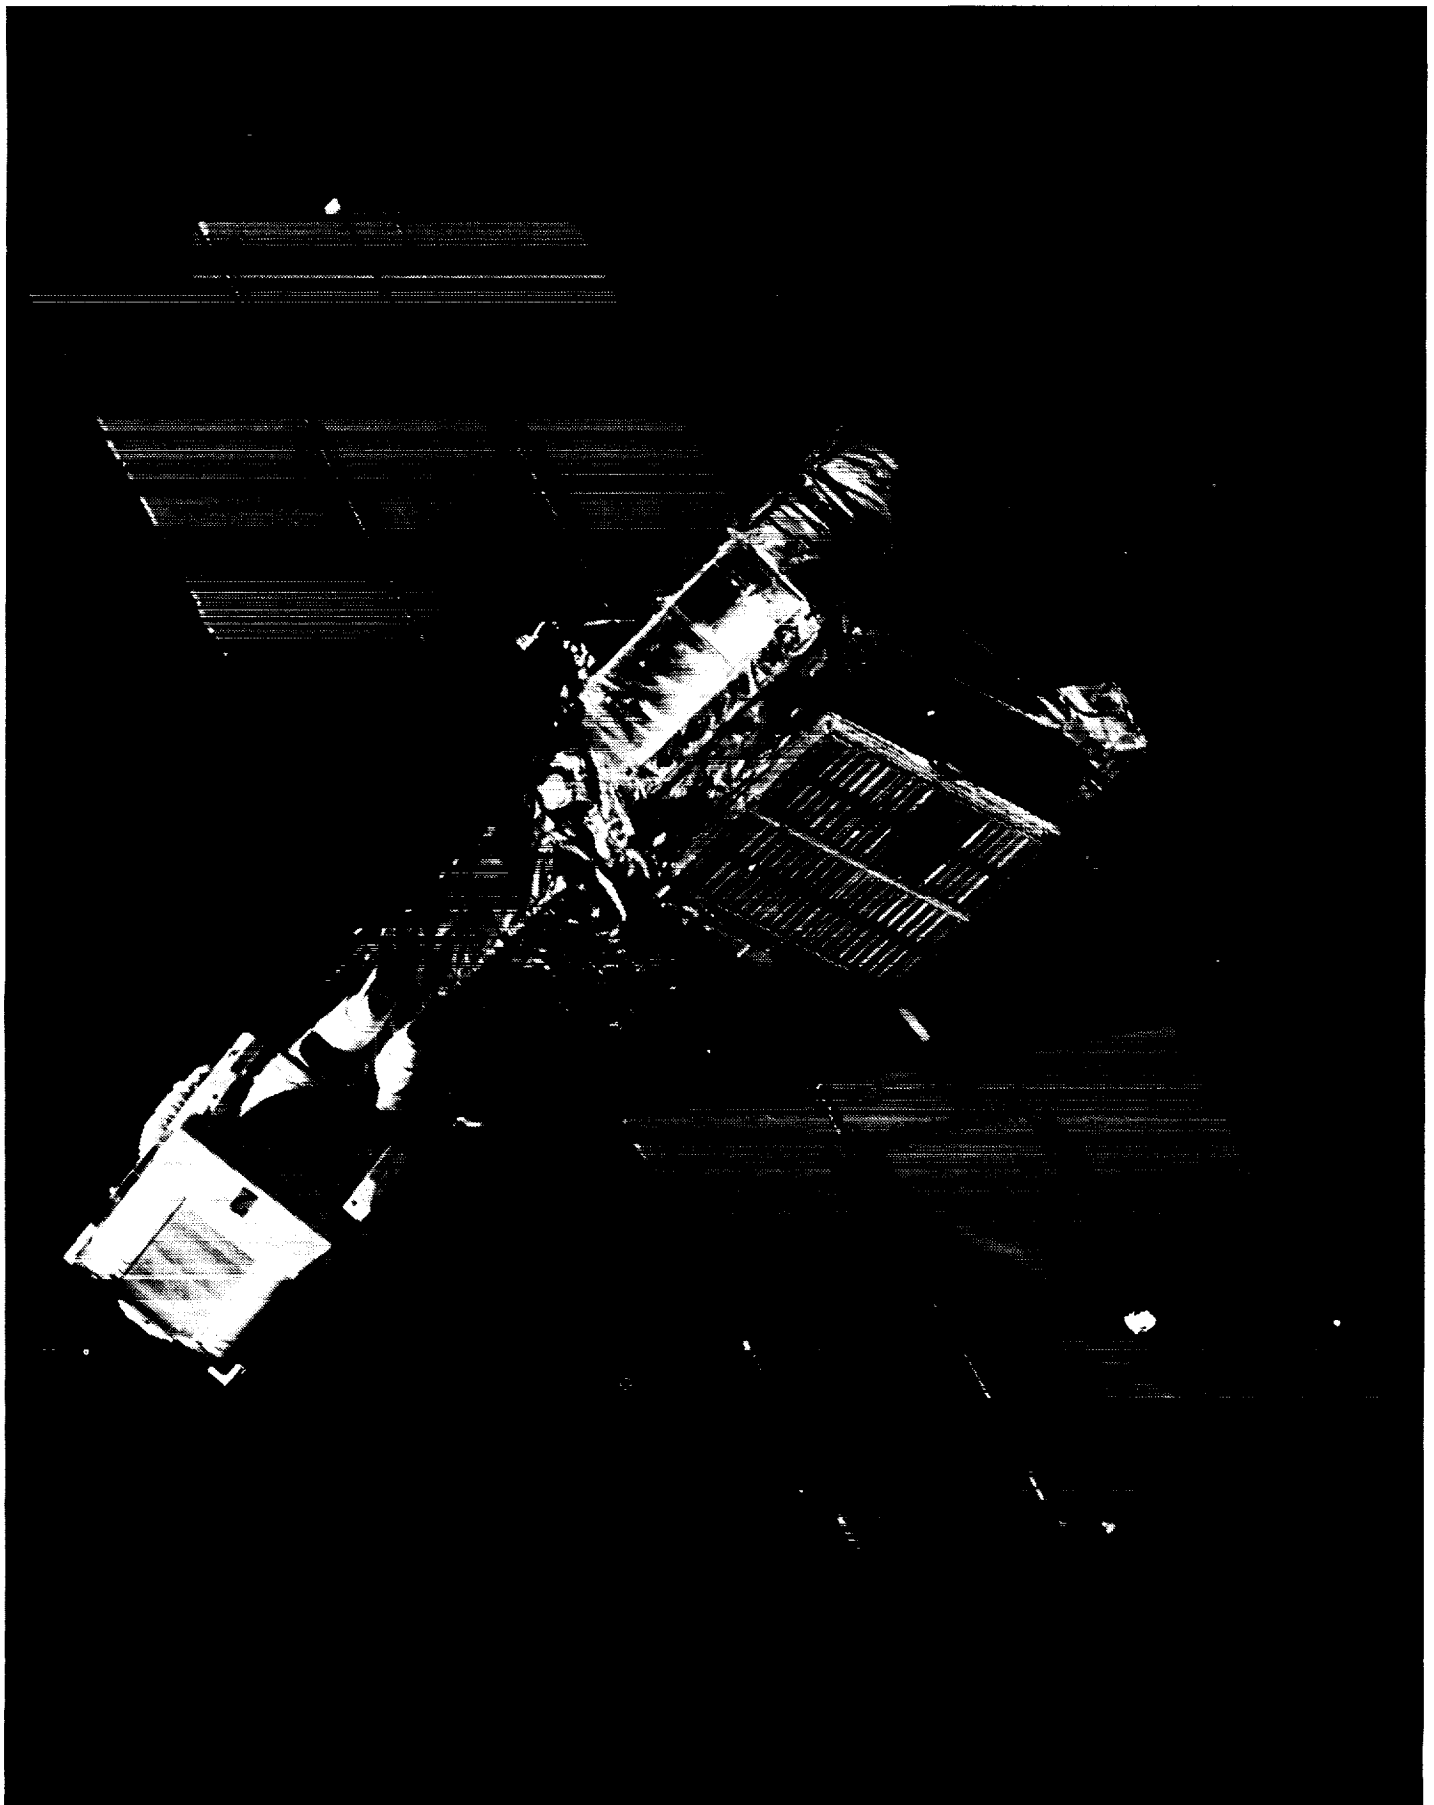
View of MACS module after unsuccessful dock attempt. Most louvers are closed. Degradation of bottom-facing louver trim can be seen.

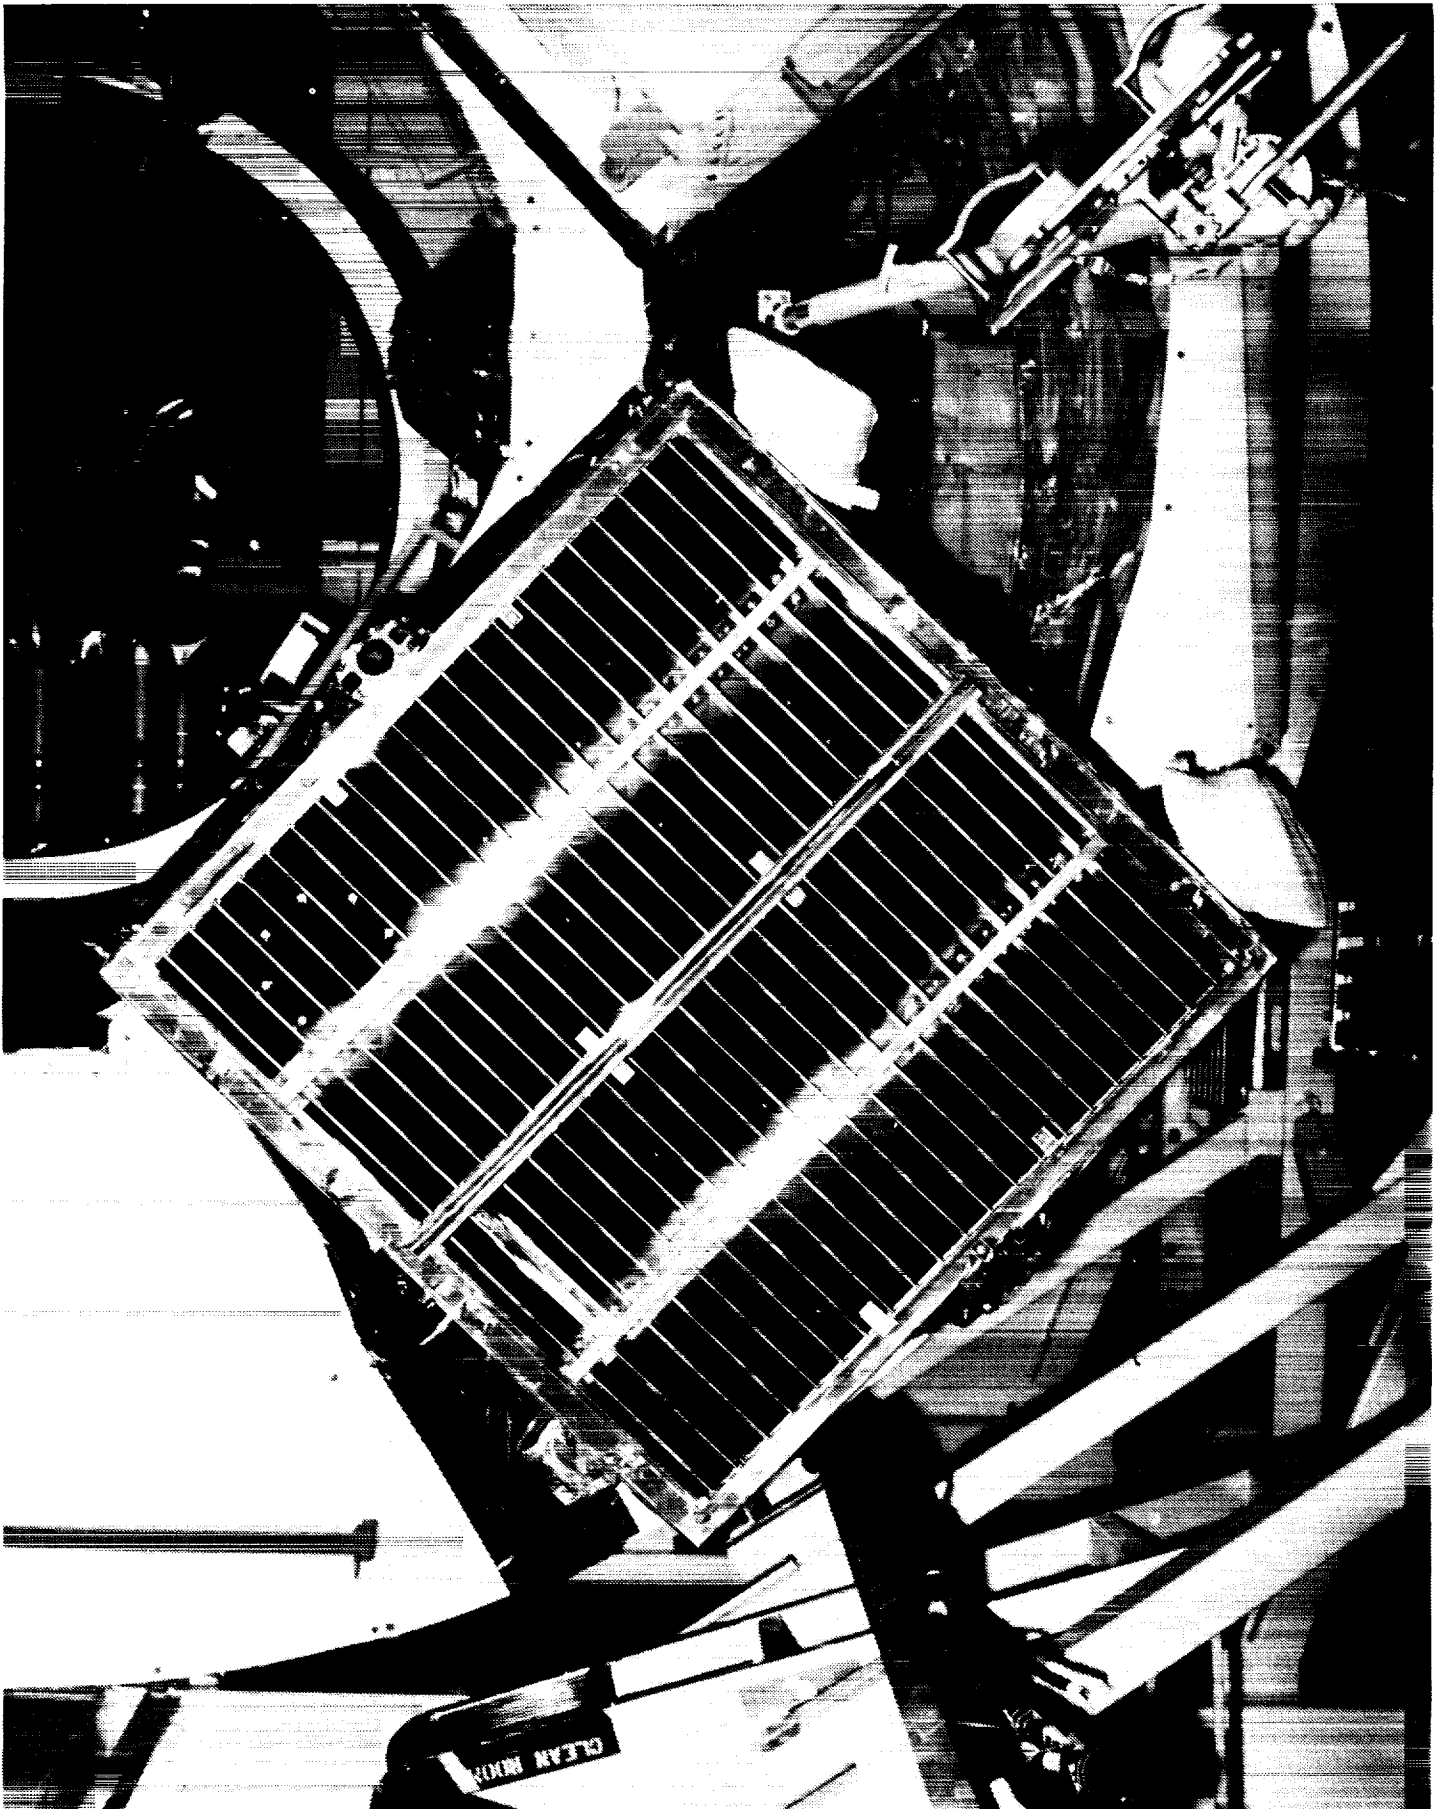
MACS Module Baseplate, after landing. Taken at KSC while still attached to FSS. Fading of black paint was caused by separation and “creep” of oil from thermal grease compound under (gold-colored) louver actuators. Louver blade sent by astronaut is also visible.

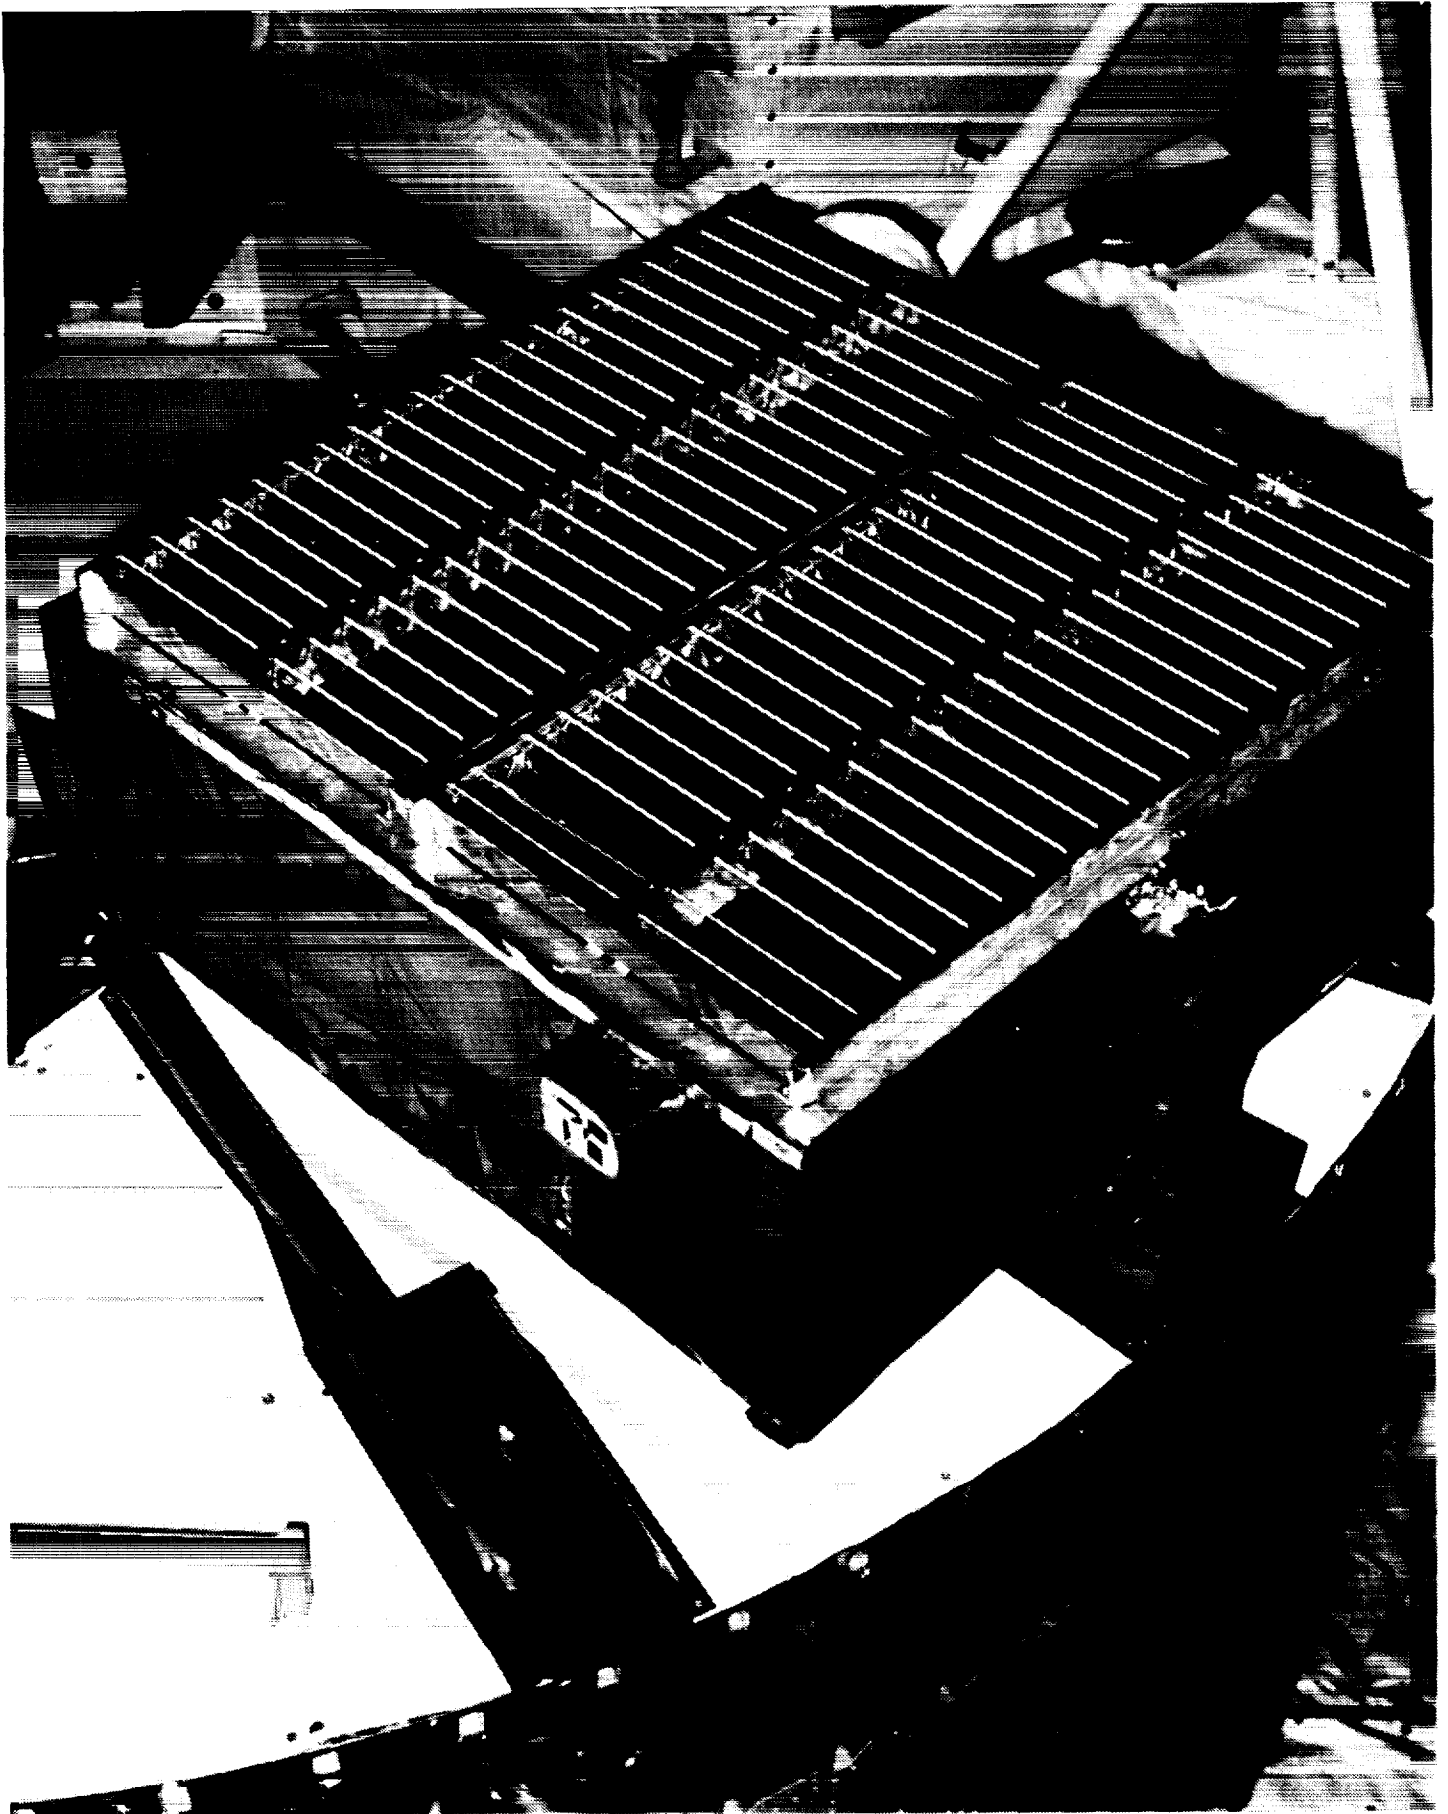
Close-up of the degraded silver Teflon louver trim, on the “bottom” side to solar radiation and the atomic oxygen fluence on the silver/Inconel side of the silver Teflon.

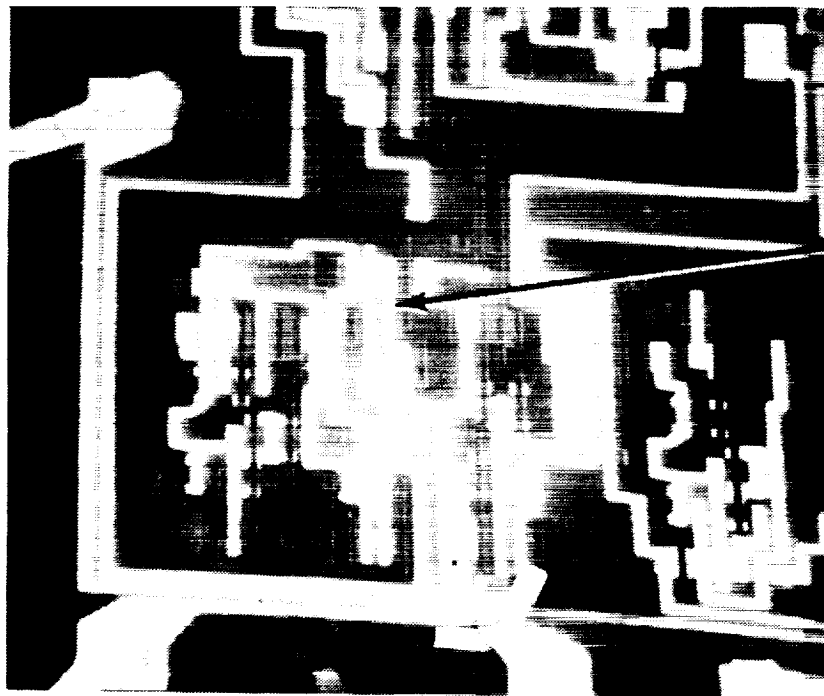
Output-0 volts  
not correct.

Figure 1. Photomicrograph of failed counter stage. (Light areas indicate zero volts. Dark indicates  $V_{DD}$ ).

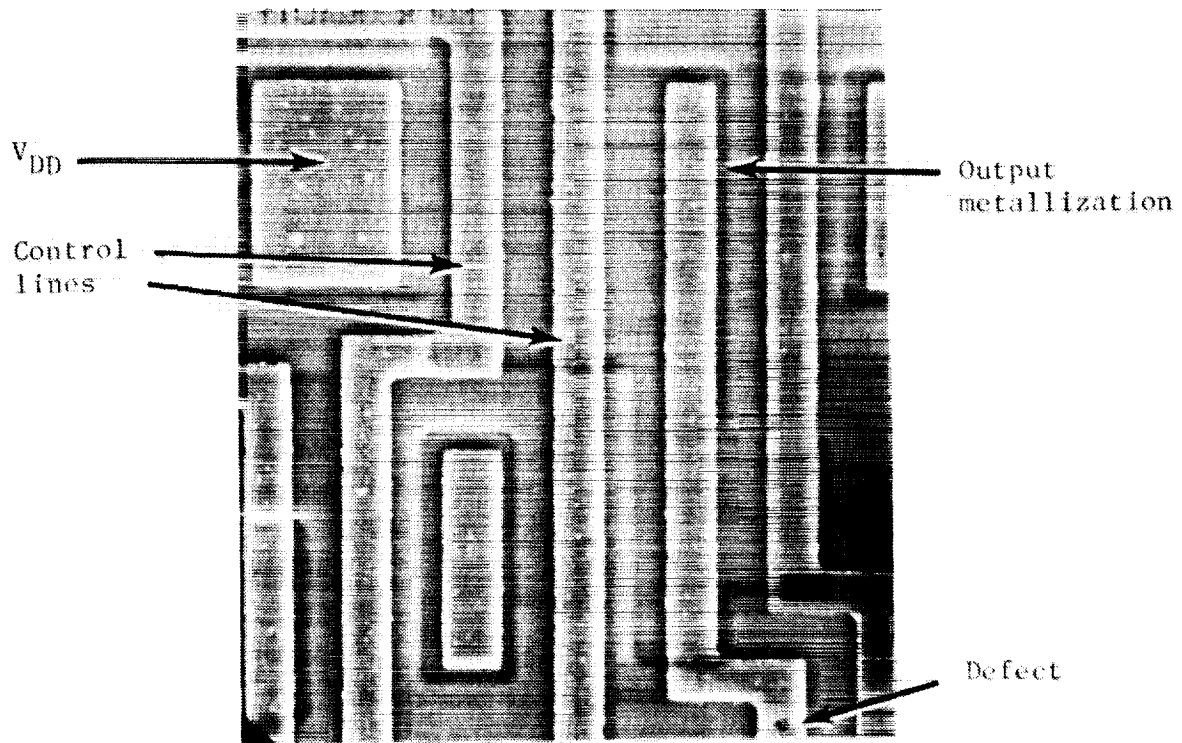
Figure 3. Photomicrograph of failed output stage. 800X

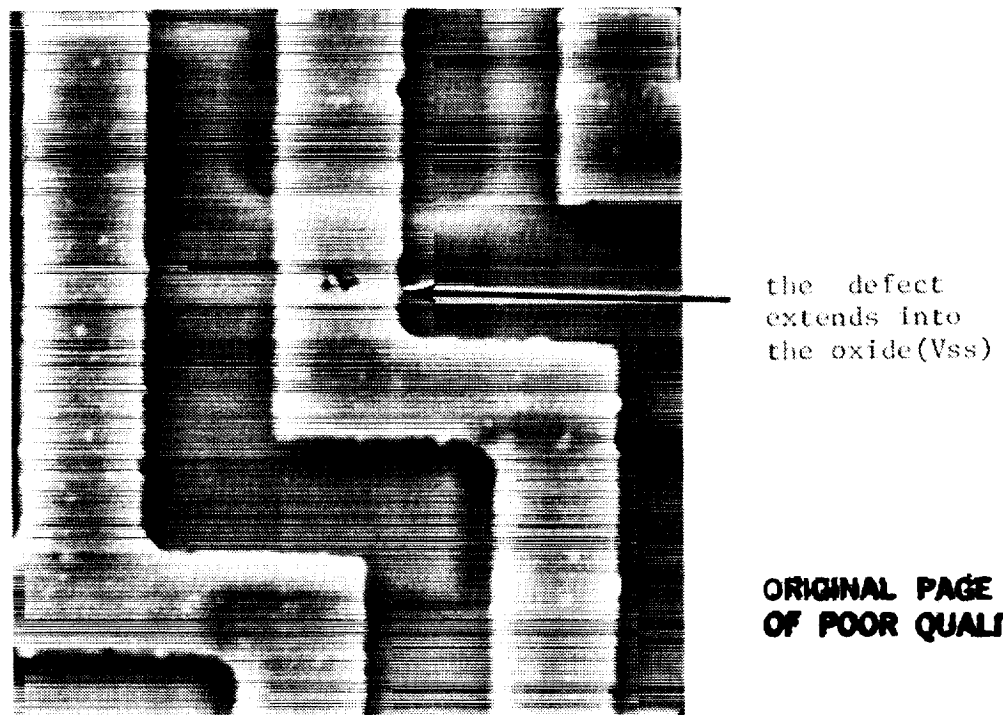
Figure 4. Photomicrograph of defect affecting output metallization. 2000X

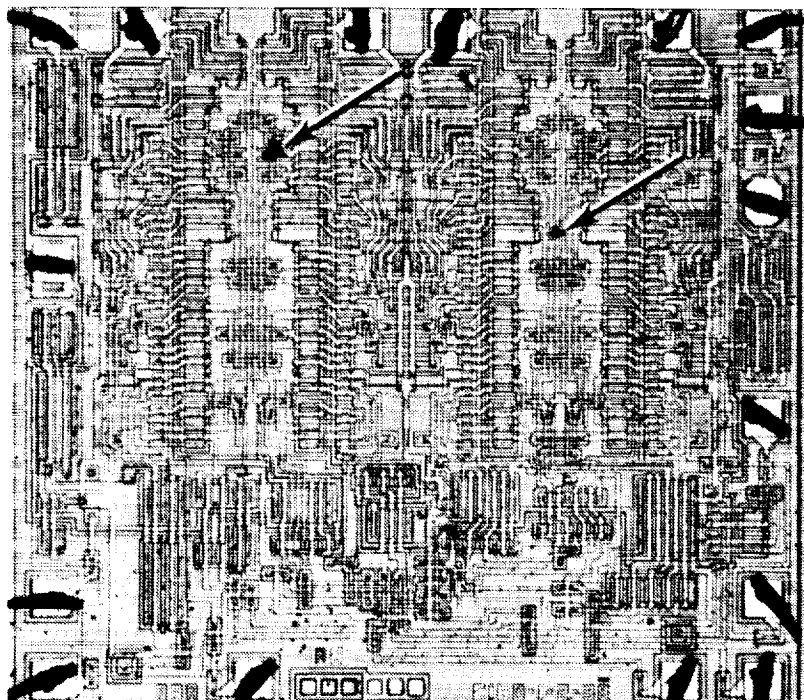
Fig. 1. Photomicrographs of die surface contamination (SN 139)

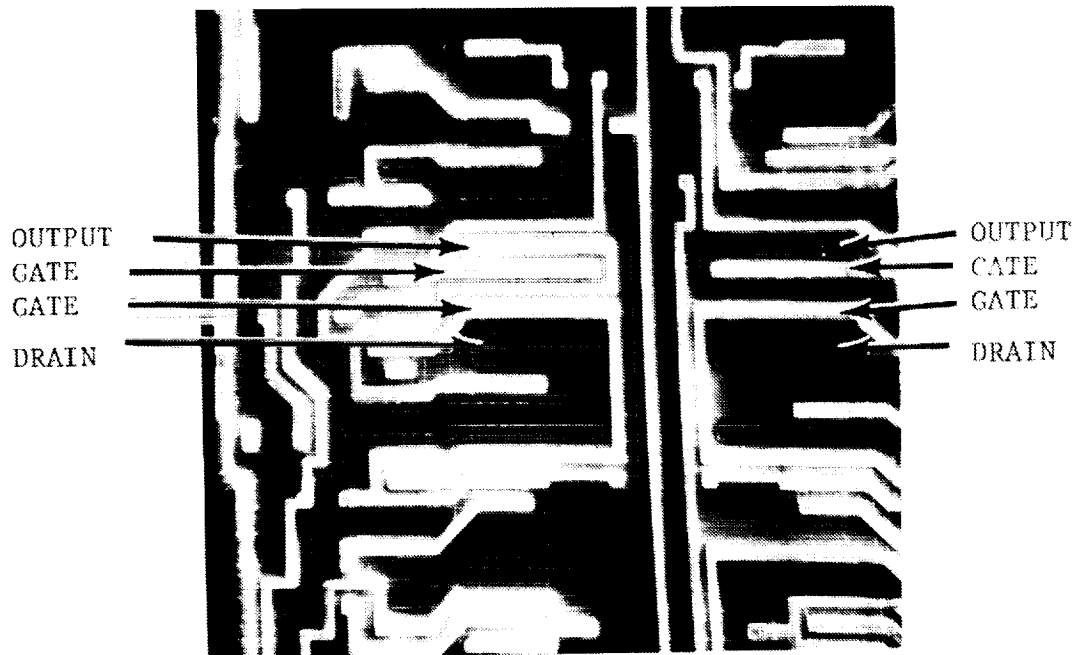
Fig. 2. SEM Micrograph of the failure utilizing Voltage Contrast. (SN 135) the A output stage (left) failed.

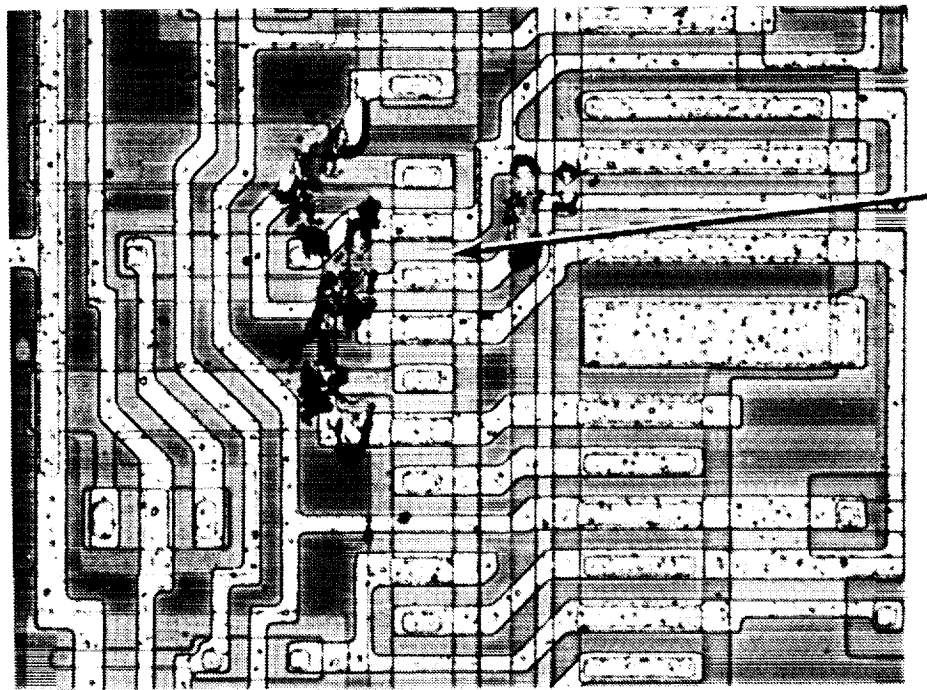
Fig. 3. Photomicrograph of the failure site isolated utilizing the microprobe station. (SN 135)

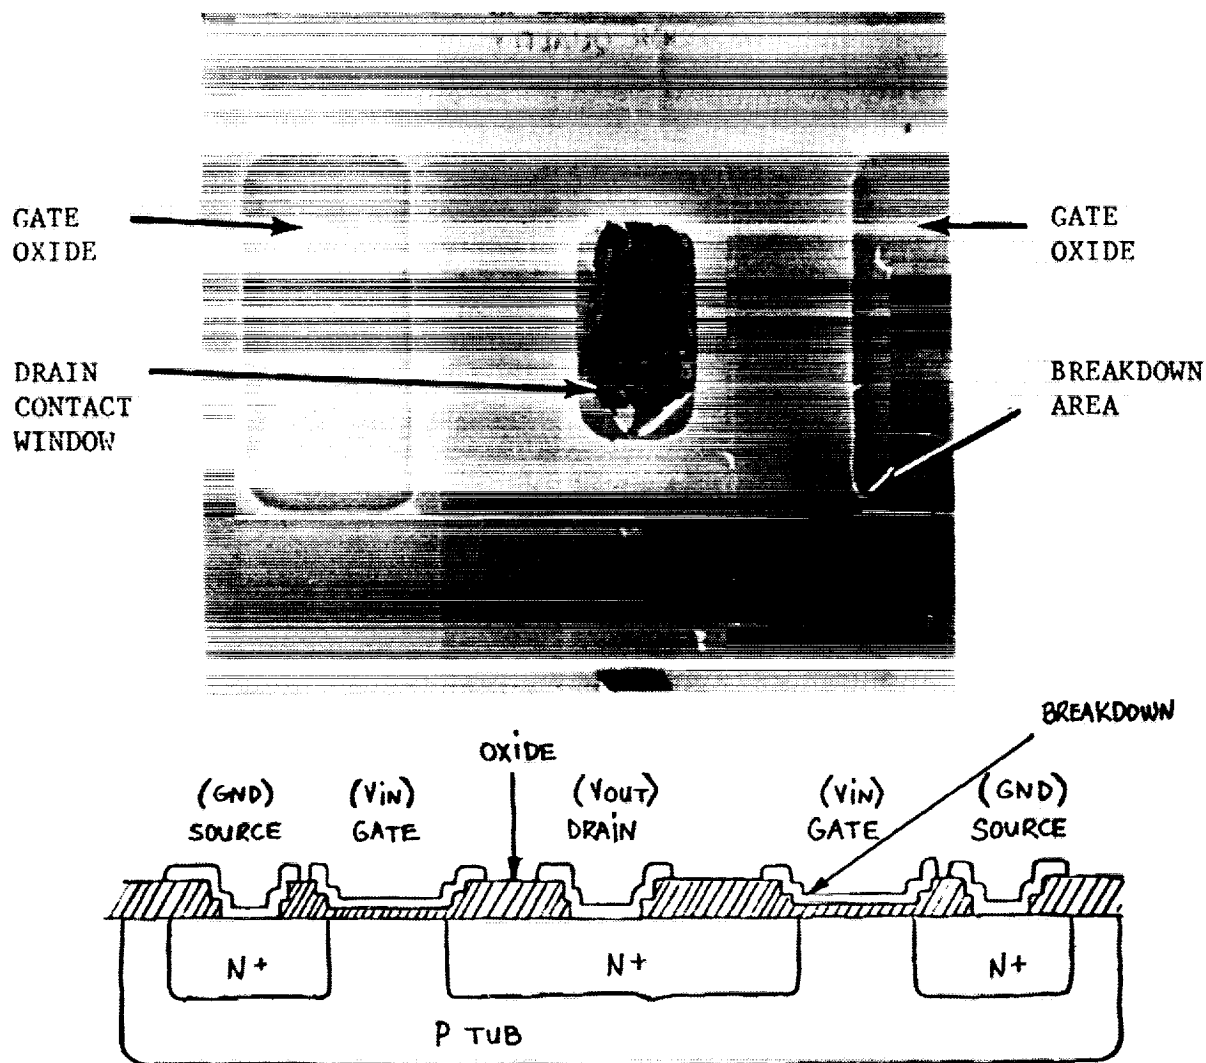
FIG 4. SEM Micrograph of the failed N-channel transistor.(SN 135)

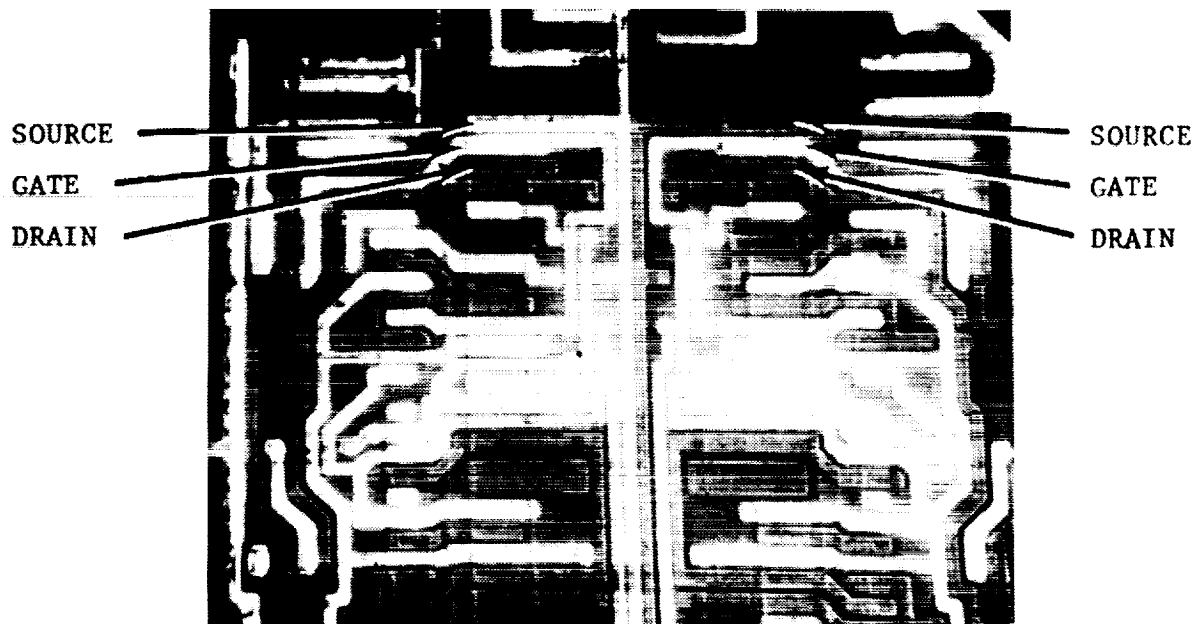
Fig. 6. SEM Micrograph of the failure utilizing Voltage Contrast. (SN 128) left is stage A (failed)

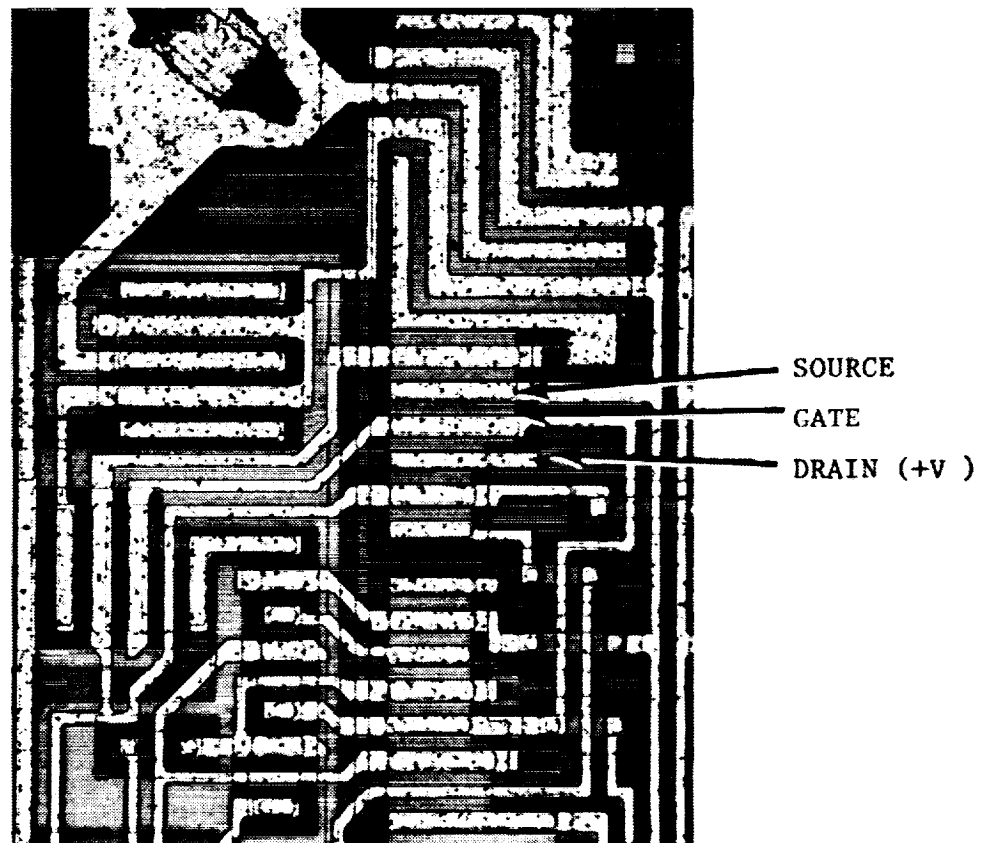
Fig. 7. Photomicrograph of the failed counter stage. (SN 128)

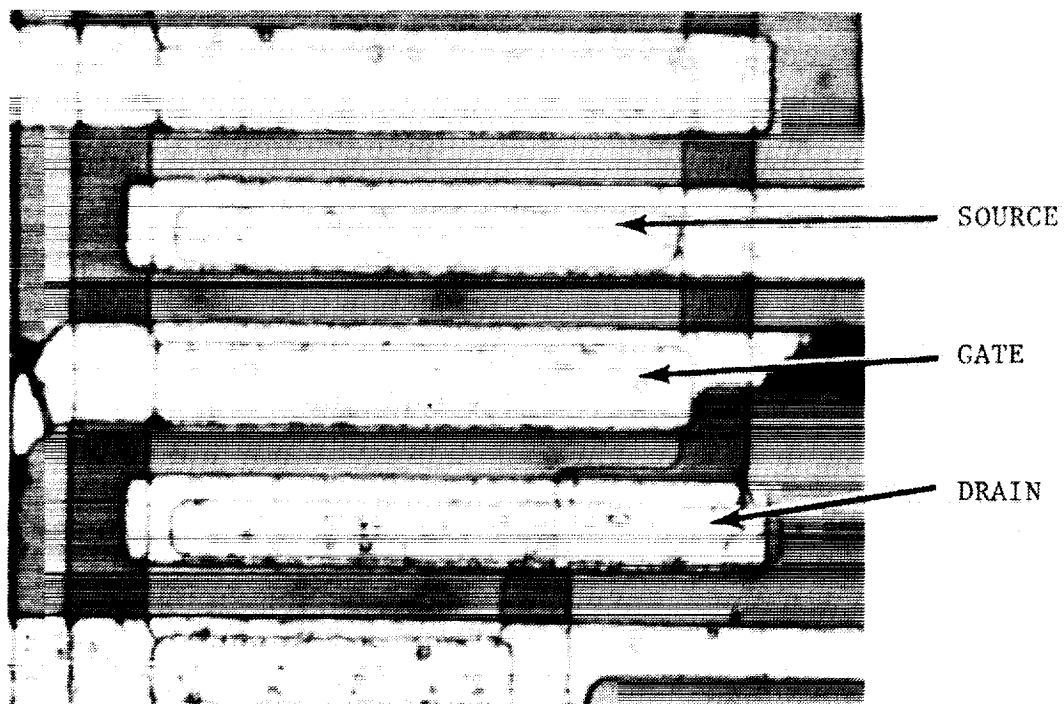
Fig. 8. Photomicrograph of the failed P-channel transistor. (SN 128)

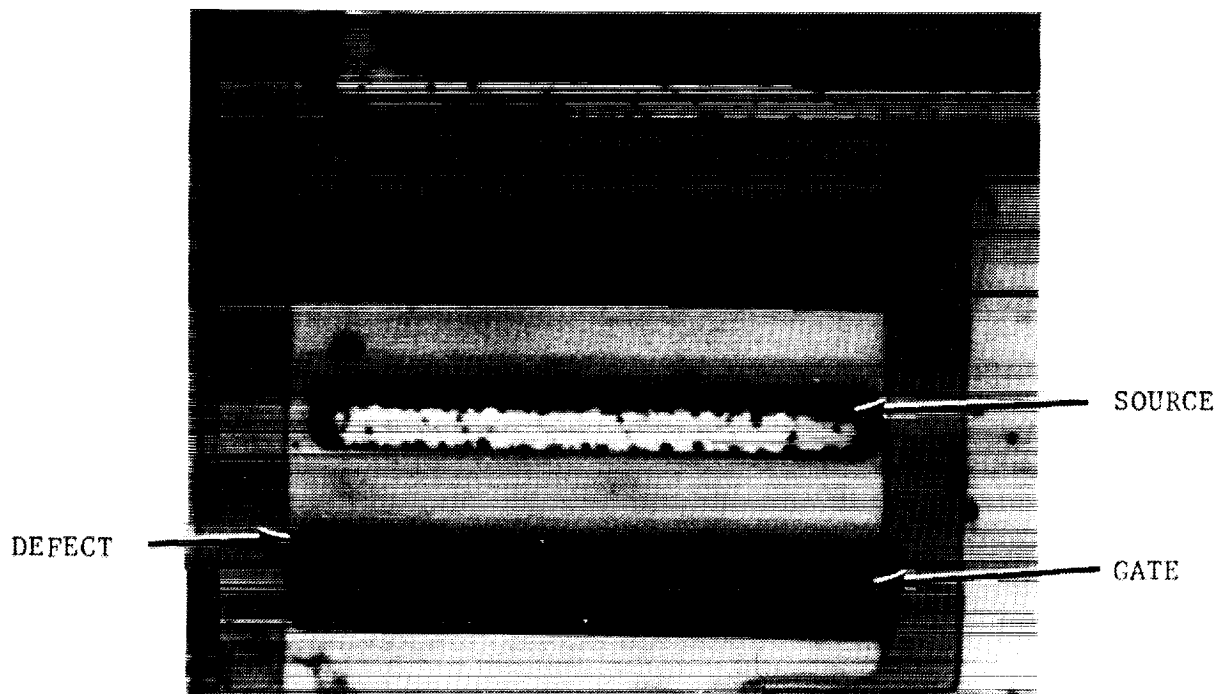
Fig. 9. SEM Micrograph of the failed area after an aluminum etch. (SN 128)

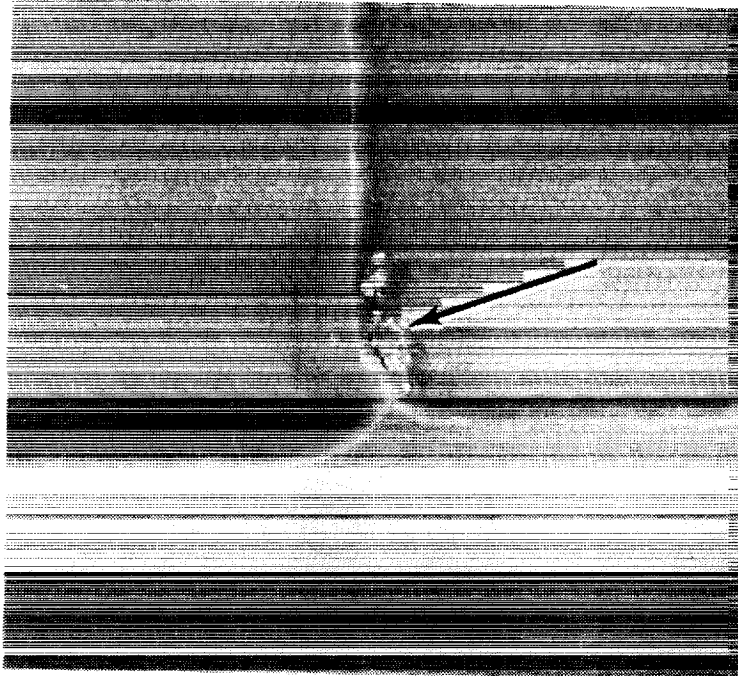
Fig. 10 SEM Micrograph of the defect in the gate oxide (SN 128)

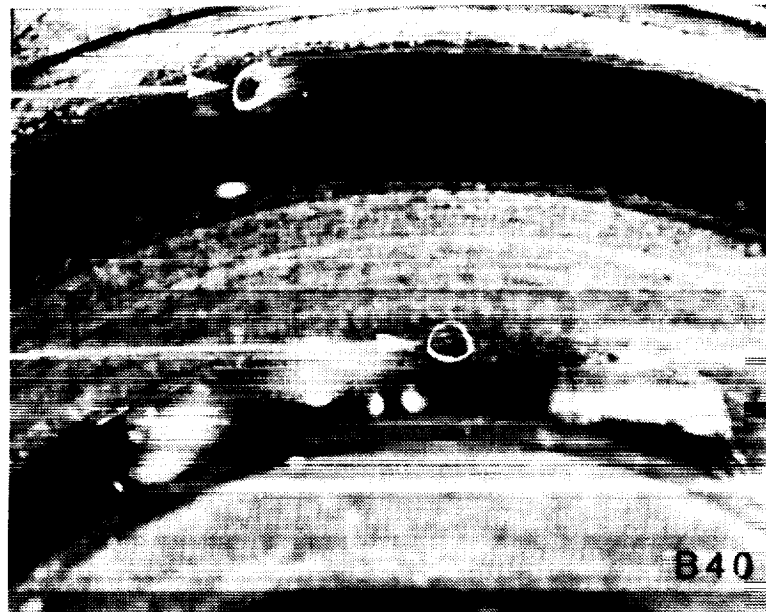
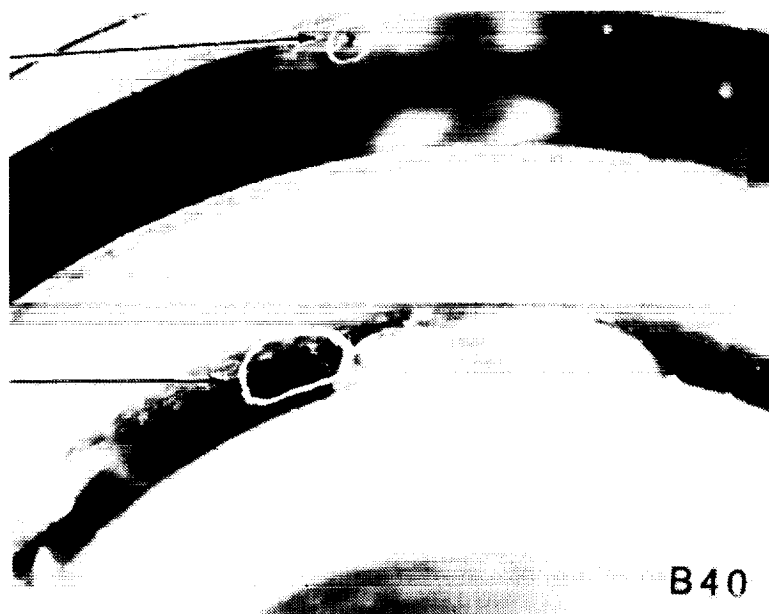
The bearings showed some wear in the form of tiny pits and scratch-line deformations. Numerous tiny particles were observed clinging to the bearing parts after the case and the hysteresis ring were removed. The particles had originated from the pits of the bearing races and the balls.

Figure 4. Typical particles observed clinging to B40 while still in gyroscope., 20 $\times$ .

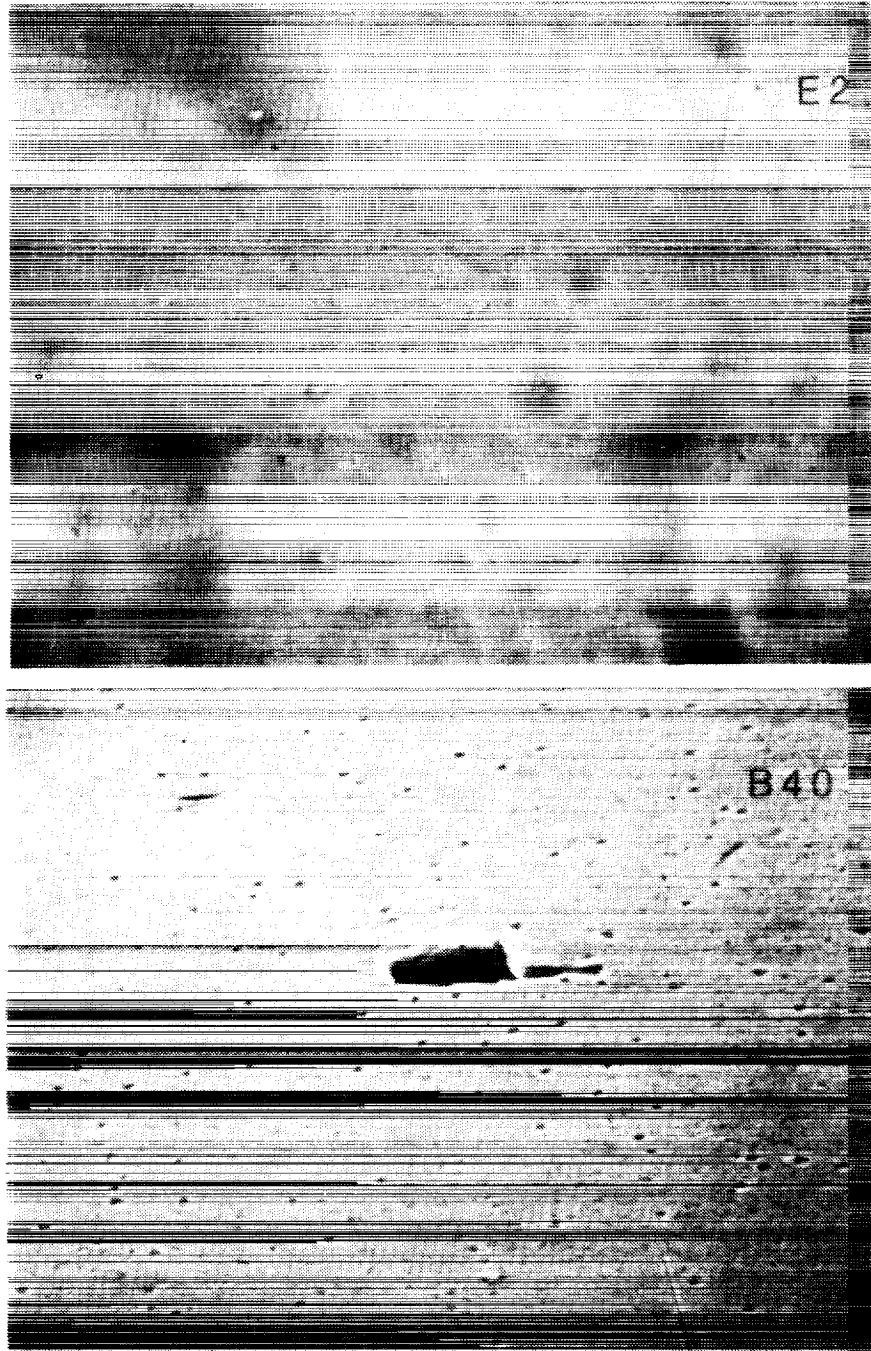
Figure 10. SEM photos of balls from E2, top, and B40, bottom. Note “large” pit is 115 square micrometers. 1250 $\times$ .

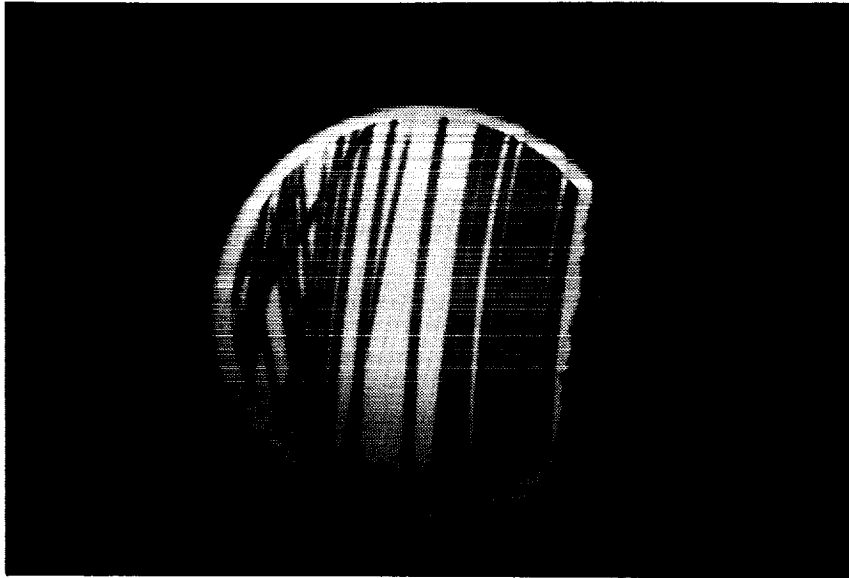
Photo cathode of Standard Star Tracker S/N 002 showing damage caused by the sun during SMM recovery. Lines are regions where heat from the solar image evaporated the cathode material resulting in regions of no sensitivity.

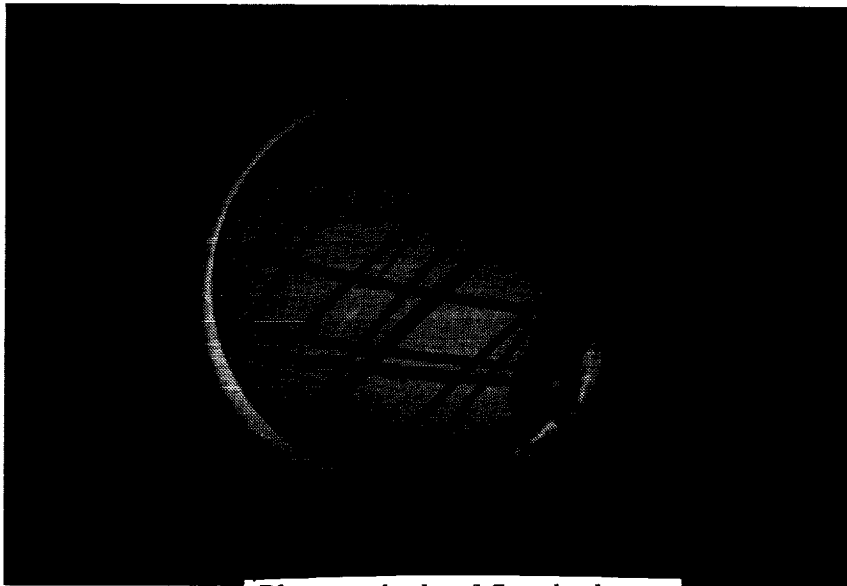
Photo cathode of Standard Star Tracker S/N 001 showing damage caused by the sun during SMM recovery. Lines are regions where heat from the solar image evaporated the cathode material resulting in regions of no sensitivity.

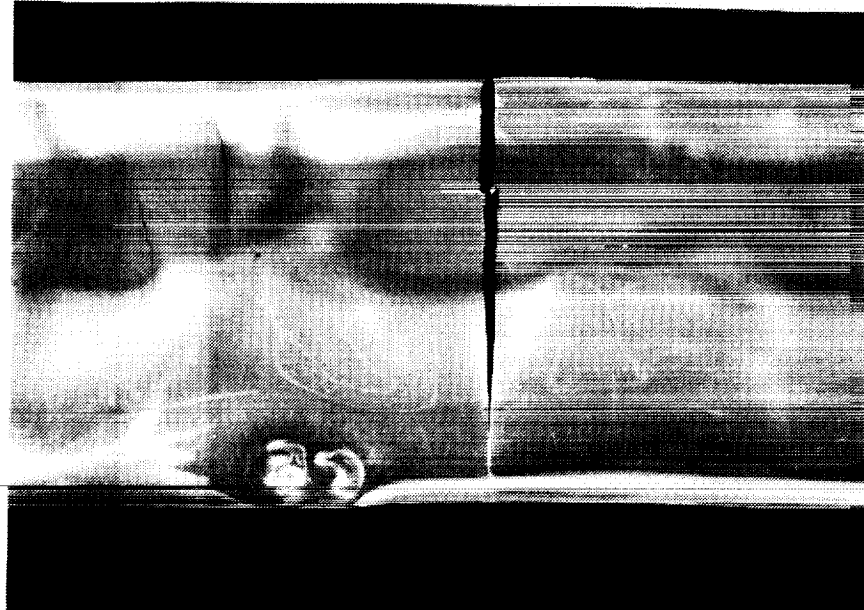
The result of exposing the Inconel in this way was the apparent removal of the vapor deposited metals (Figure 2) in a narrow strip of approximately 1/3 of the total width of deposited metal. The width of the total exposed surface was about 2-1/4 inches and the eroded surface, though non-uniform and irregular, was about 3/4 inch, or about 1/3 of the total exposed surface's width. In addition, the separations in the Teflon film ran essentially to the edges where the film was adhered to the U-channel which kept the film from coming loose.

Figure 2. Silver/Teflon film showing area having lost deposited metallic films, from bottom (B2) of ACS, with separation running across the short dimension of the film.

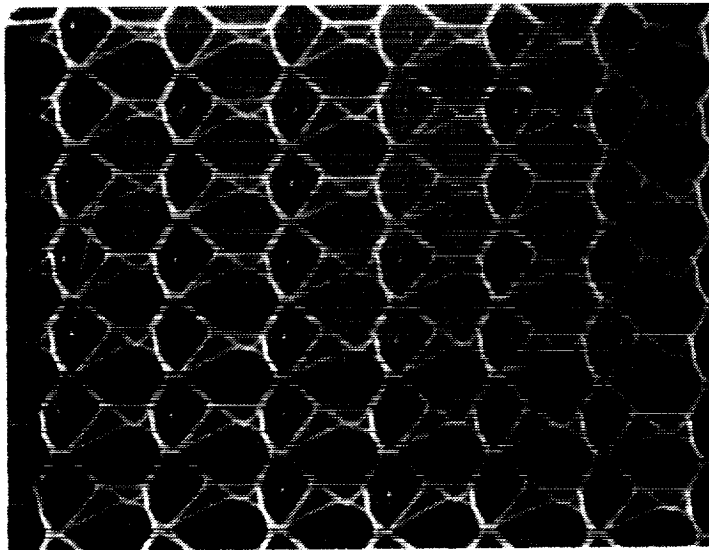
Another unusual feature of the MEB blanket was the appearance of what was an unusual pattern of light spots or reflections. Upon examining the back of the outer Kapton layer, it was noted that the aluminum deposit had been rubbed off, making it appear that there had been holes in the Kapton. By comparing the rubbed pattern with the knots (Figure 9) of the Dacron mesh in the thermal blanket, one can demonstrate how the pattern occurred.

Figure 9. Back-lighted MEB Kapton showing lighted areas adjacent to knots in the Dacron mech, demonstrating how the deposited alulminum was removed.

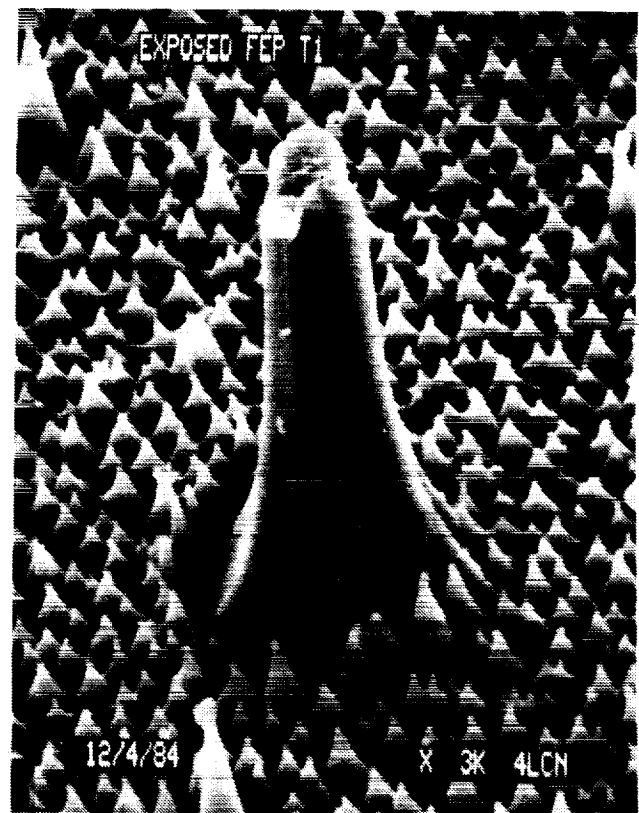
Figure 12

T1 FEP Teflon Exposed Ag/Inconel Side. The Morphology is Similar to that of the Laboratory Exposed Ag/Inconel with Ag Growing Through Cracks and Grain Boundaries in the Inconel Overcoat. At High Magnification it is Possible to Observe Regions in which the AG/I has been Totally Removed and the FEP Teflon Textured Surface is Visible.
